# Oak Hills Homeowners Association

## Level 1 Reserve Study

**Report Period - 1/1/2025 to 12/31/2025**

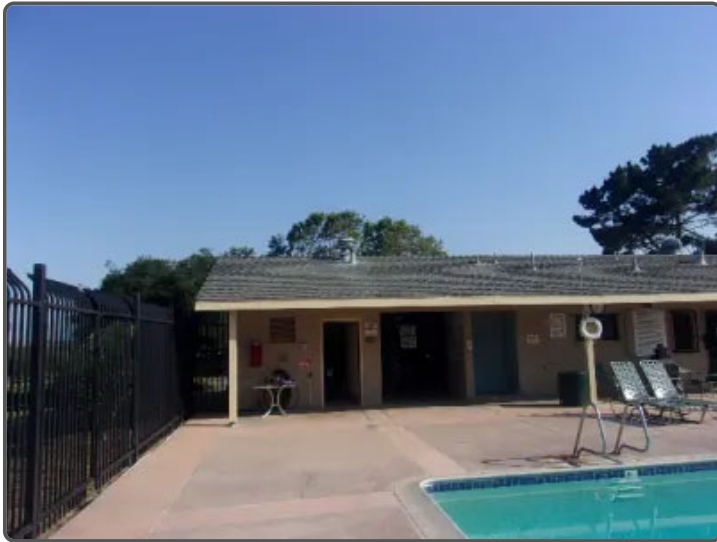
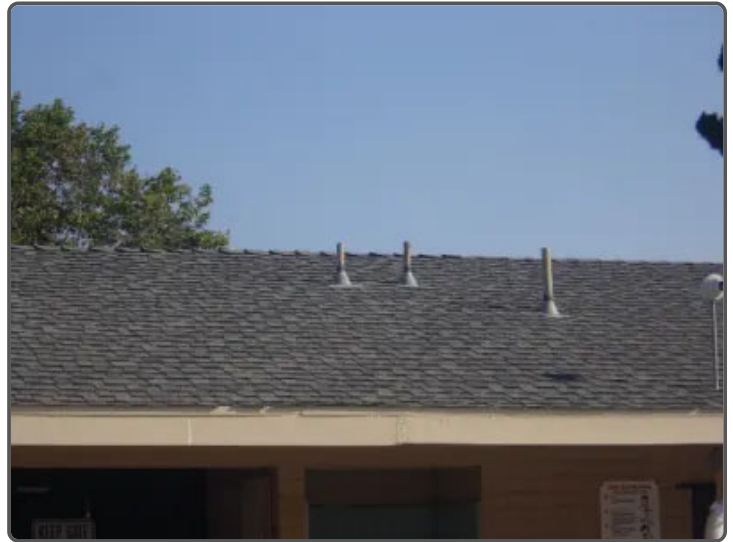
No problems noted or reported at time of site visit. Typically this type of roofing material has a useful life of approximately 20 to 25 years. Inspect roofs regularly and make local repairs as necessary as an operating issue to ensure full life from this roof. Remaining life based on current age.

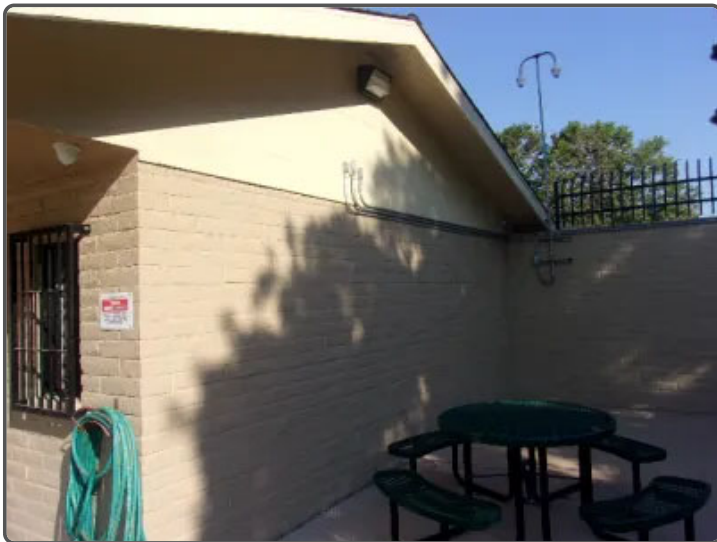
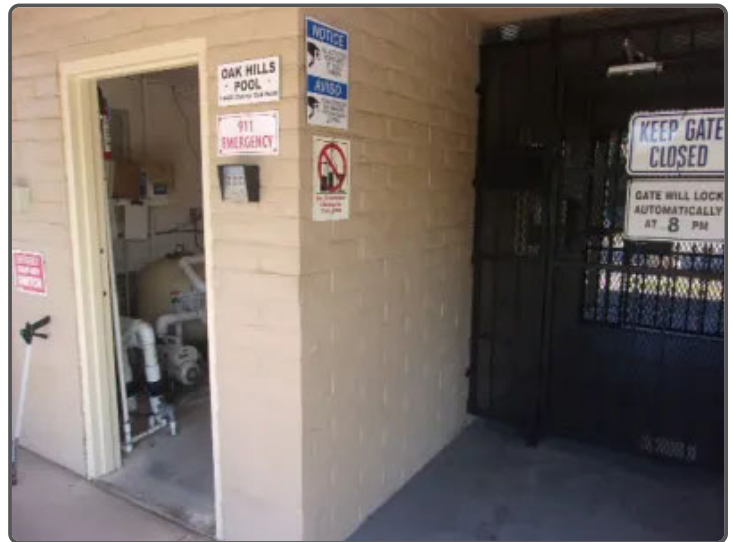
Comp # 201 Building Exterior Surfaces - Repaint

No significant staining or discoloration noted at time of site visit. We recommend funding to repaint these surfaces approximately every 10 to 12 years to maintain appearance and protect the surfaces. Remaining life based on current age.

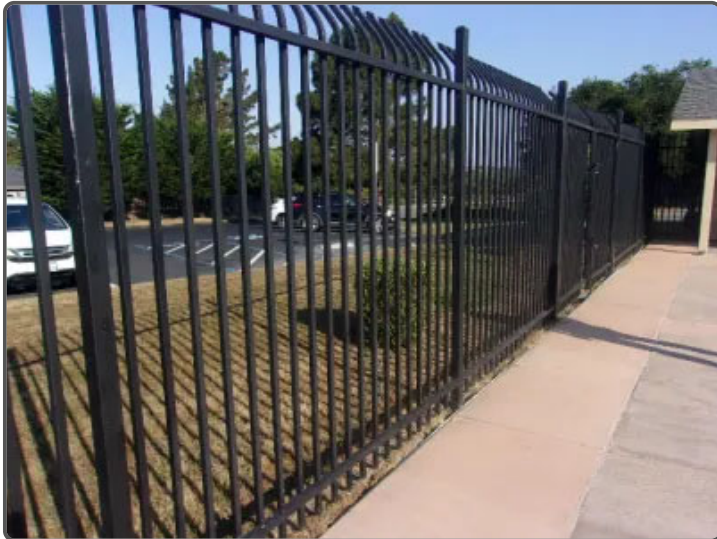
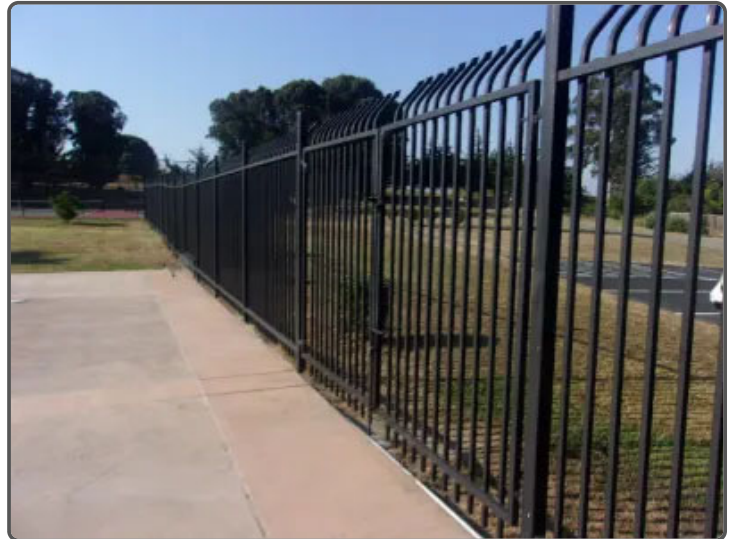
**Comp #**      **207**    **Wrought Iron Fencing - Repaint**

No appearance concerns or rust intrusion noted at time of site visit. We recommend funding to repaint this fencing approximately every 3 to 5 years to maintain appearance and protect the surface. Remaining life based on current age.

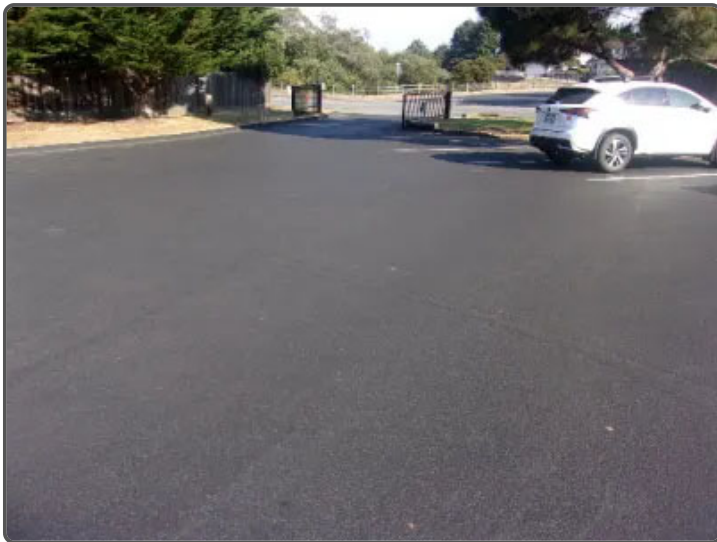
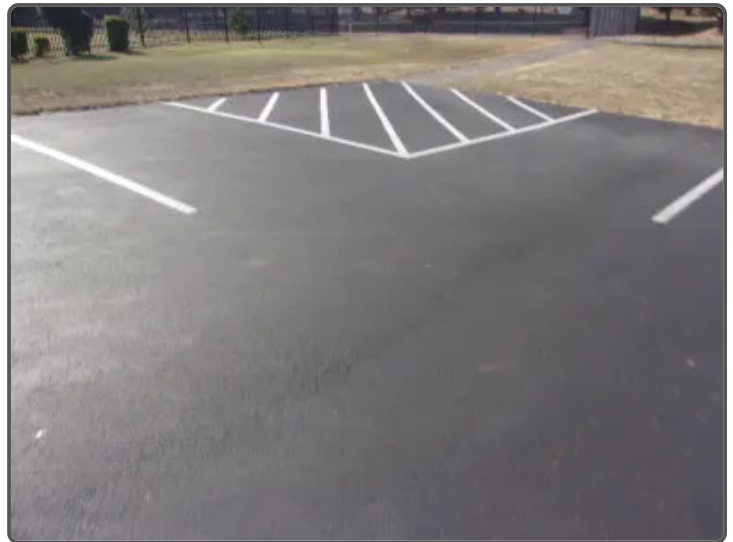
**Comp #**      **401**    **Asphalt - Major Rehab.**

With regular preventative maintenance (see Comp# 402 Asphalt - Preventative Maintenance) asphalt surface should reach a typical useful life of 30 plus years. Once the asphalt has reached the end of its useful life there are two main categories for rehabilitation: overlay and replacement. An overlay typically involves overlaying the existing asphalt with 1.5 - 2" of new asphalt. Replacement typically involves either completely removing and replacing the asphalt or pulverizing the existing surface in place and using it as a base for a new asphalt surface. An overlay will cost significantly less than replacement but may not be possible if the condition of the existing surface is in poor condition and the overlayed surface will only reach a useful life of 10 to 20 years. The complete replacement will provide a new surface and should experience a life of at least 20 years to over 30 based on preventative maintenance. For the purposes of this study we have funded for an overlay. Remaining life based on current age.

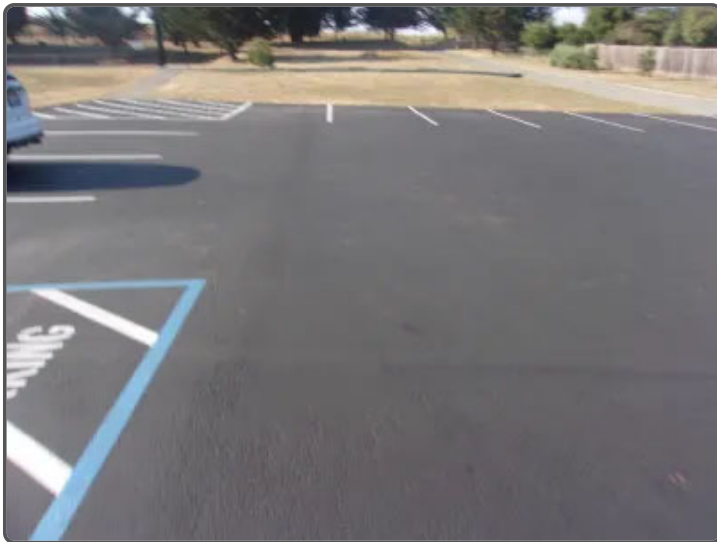
**Comp #**      **402**    **Asphalt - Preventive Maintenance**

There are two main types of asphalt sealing products, those with aggregate (slurry seals) and those without (seal coats). Seal coats provide protection from water intrusion and in general are adequate for newer asphalt surfaces or those surfaces that are in good condition. As a surface ages a more heavy duty slurry seal application may provide better protection as well as some restorative qualities. Slurry seals cost more but last significantly longer than a seal so the increased cost is more or less offset by the lower frequency of required application. We recommend having the asphalt inspected regularly by a licensed engineer or asphalt expert. Ultimately our goal is to provide adequate funding so that the board can choose the best application for their asphalt based on its current condition and recommendations from those experts that have inspected the asphalt. For the purposes of this report we have funded for a seal coat. Remaining life based on current age.

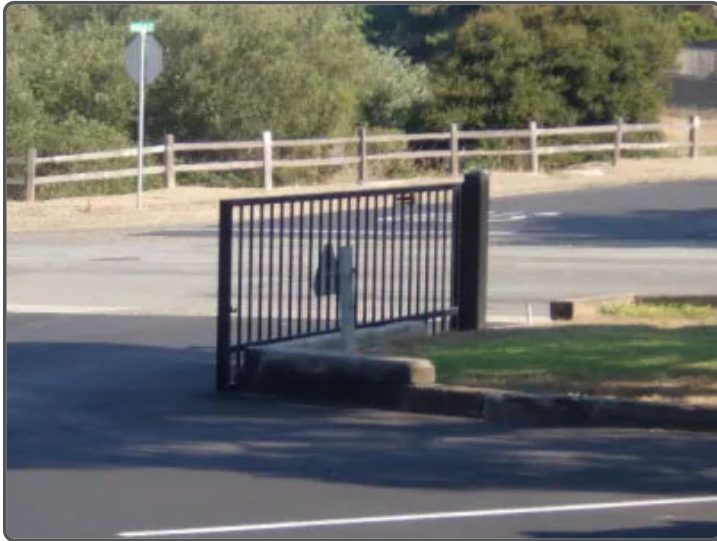
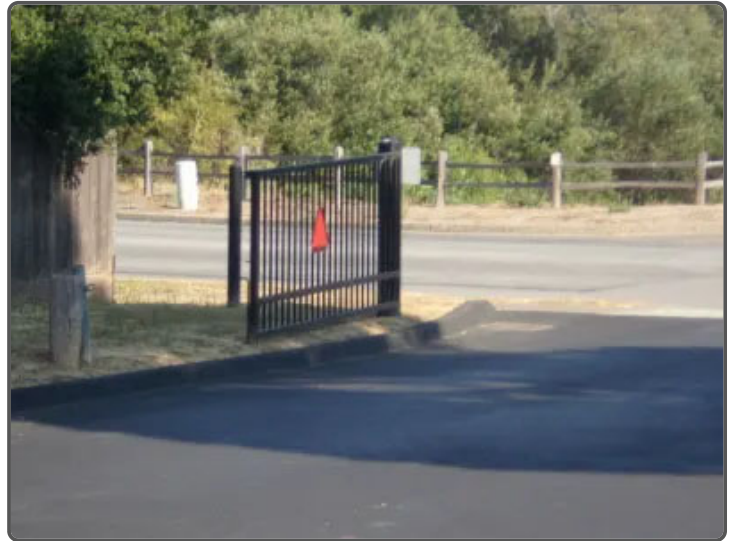
Comp #      504      Crash / Swing Gate - Replace

No problems noted or reported at time of site visit. Expect to replace this crash gate approximately every 25 to 30 years to maintain appearance and ensure proper function. Remaining life based on current age.

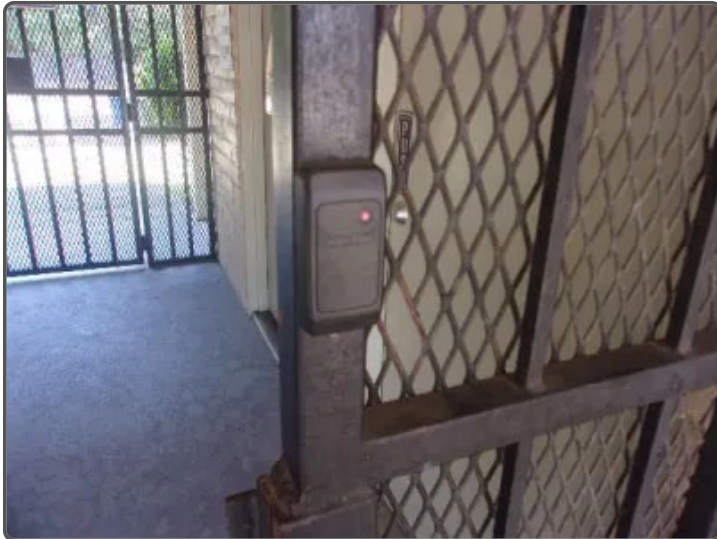
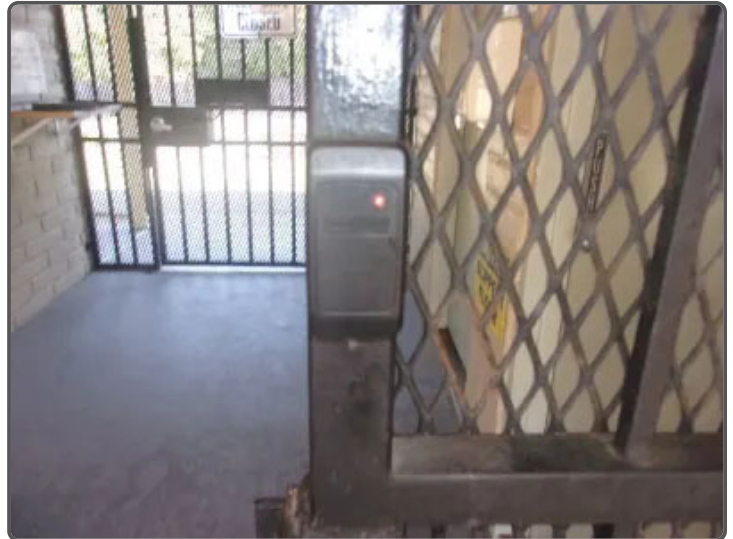
Comp # 506 Fob System - Replace

We recommend funding to replace this system approximately every 10 to 15 years to ensure proper function and to keep up with current technology. Remaining life based on current age.

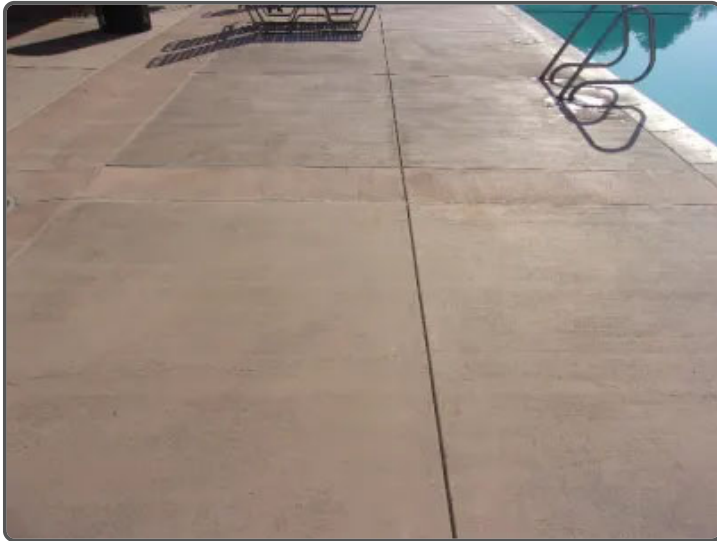
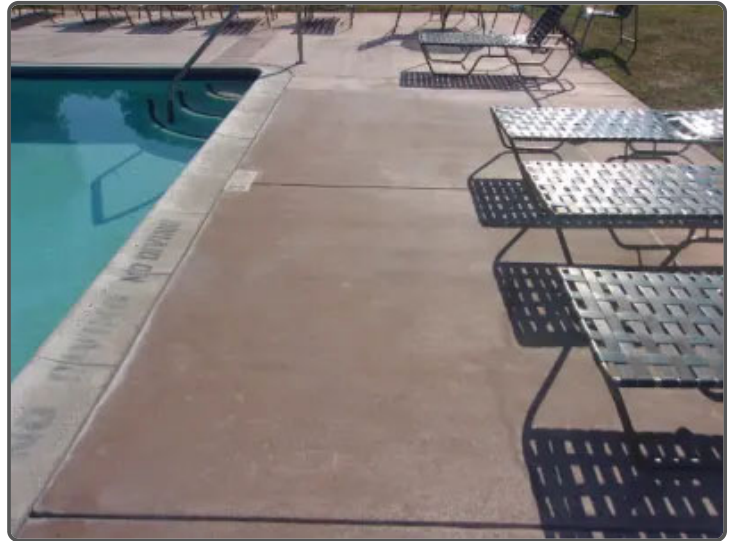
**Comp #**      **603**      **Concrete Pool Deck - Reseal/Repair**

No significant surface loss noted at time of site visit. We recommend funding to reseal and make repairs to this decking approximately every 3 to 5 years depending on use and wear.

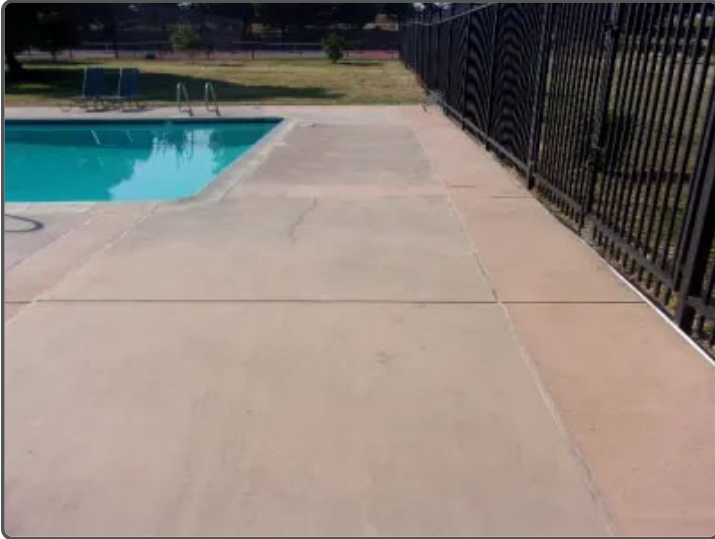
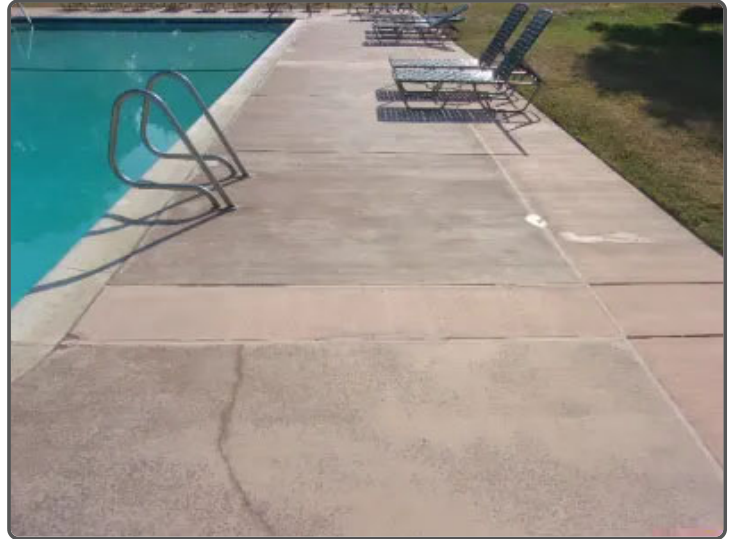
**Comp #**      **604**    **Concrete Pool Deck - Resurface / Coping**

No surface loss noted at time of site visit. We recommend funding to completely resurface this decking approximately every 15 to 20 years to maintain appearance and ensure proper function. Remaining life based on current age.

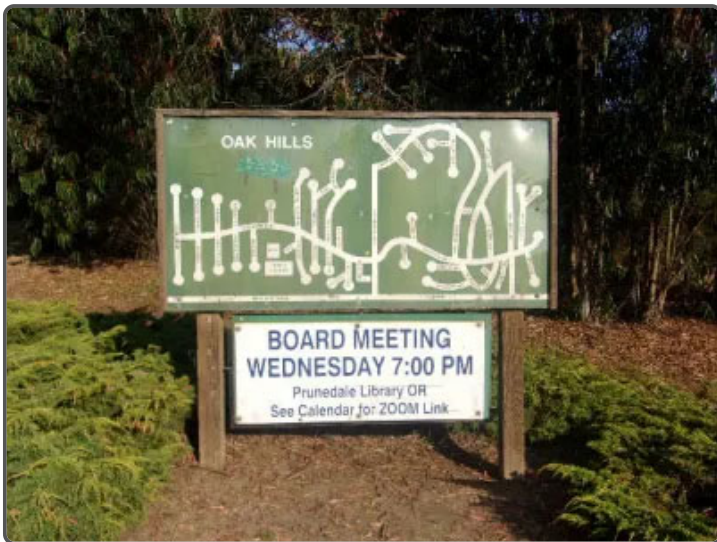
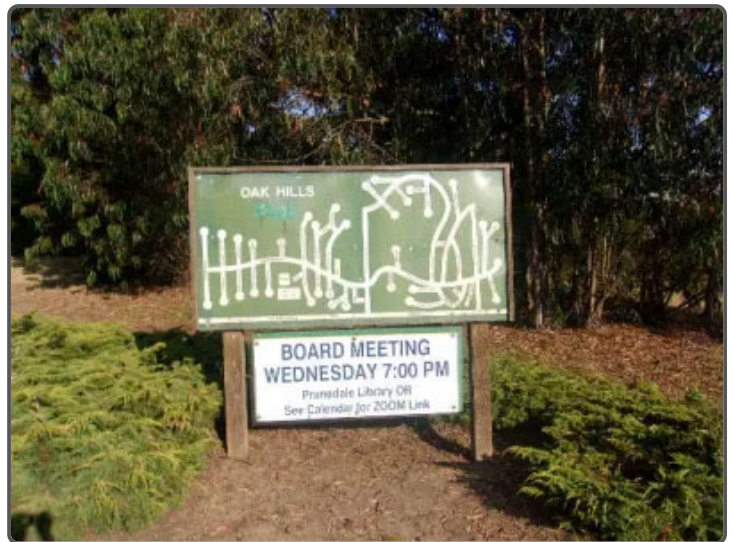
No problems noted with directory sign at time of site visit. We recommend funding to replace this sign approximately every 18 to 20 years to ensure appearance is consistent with the community. Remaining life based on current age.

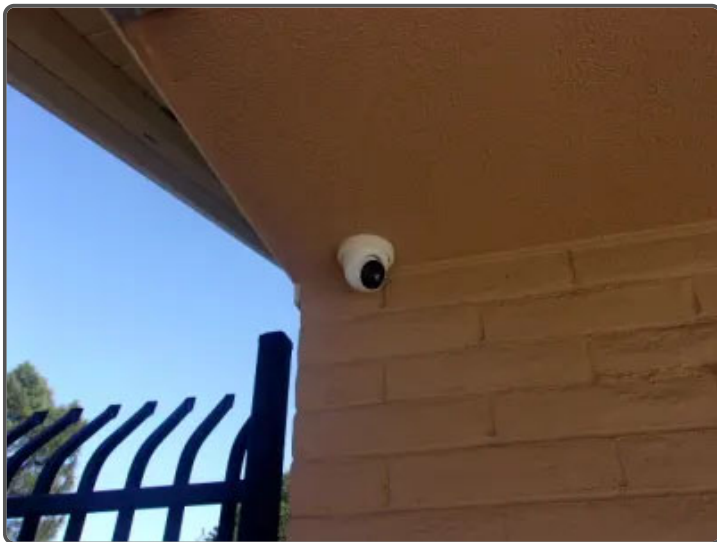
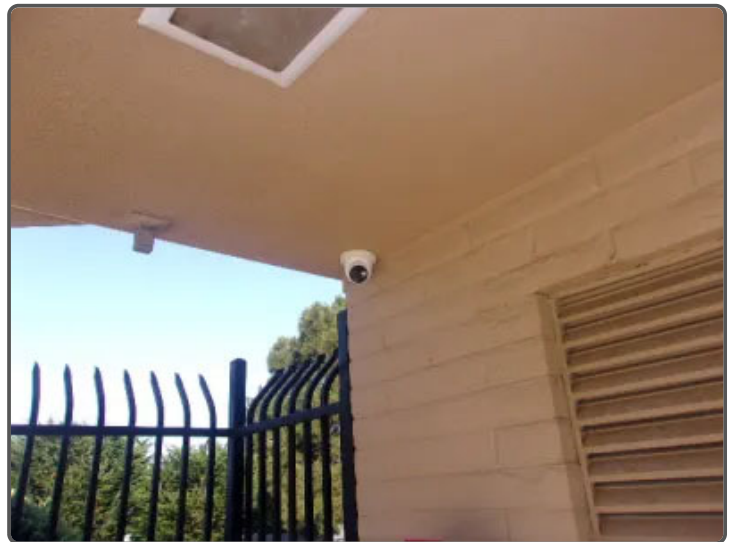
Comp # 903 Camera System - Replace

No problems noted or reported at time of site visit. We recommend funding to replace this camera system approximately every 8 to 10 years to ensure proper function and keep up with current technology. Remaining life based on current age.

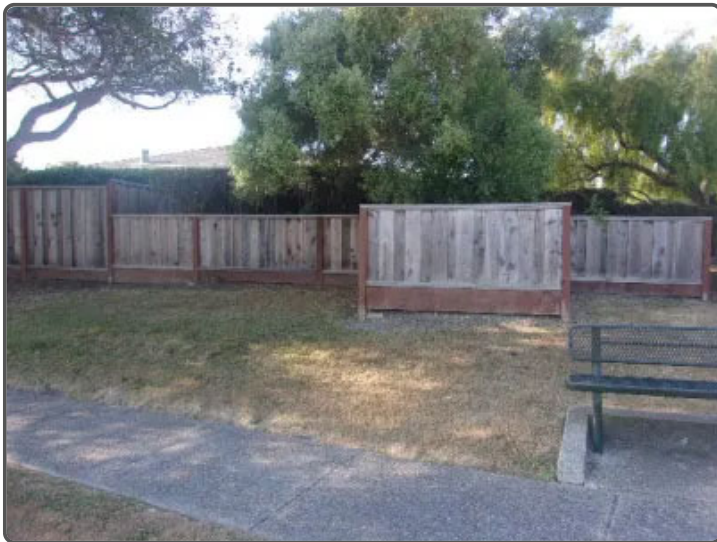
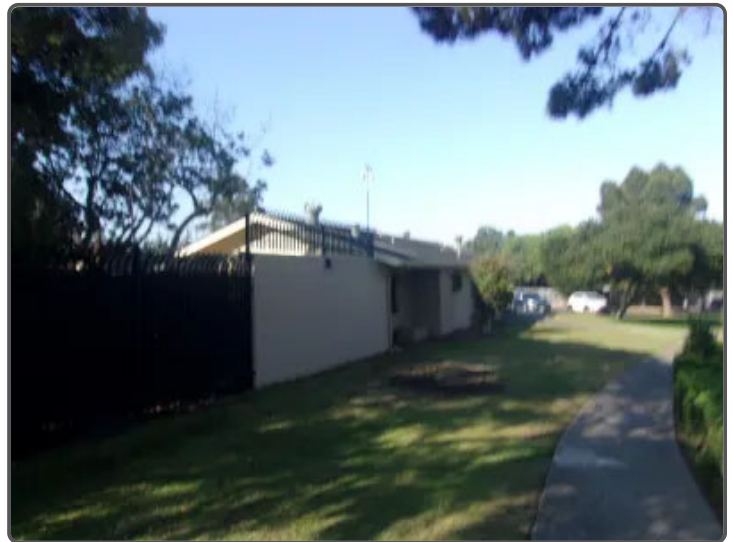
**Comp #** 1002 **Wrought Iron Fencing - Replace**

We are generally funding to make repairs and replacements as needed approximately every 5 to 10 years.

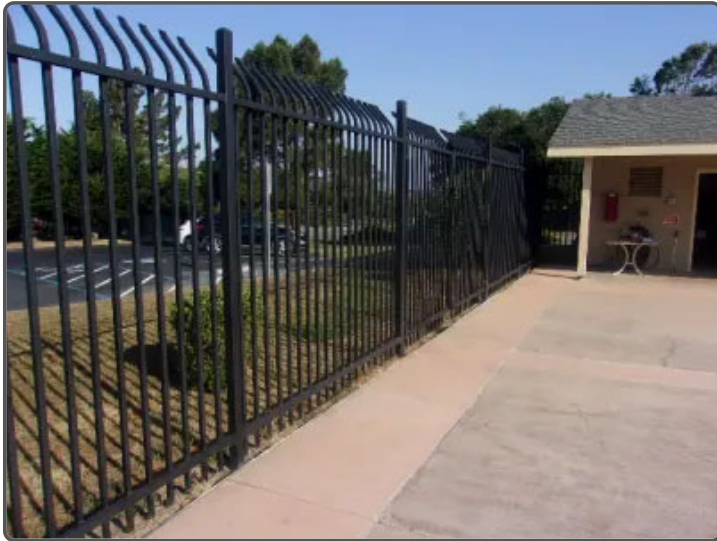
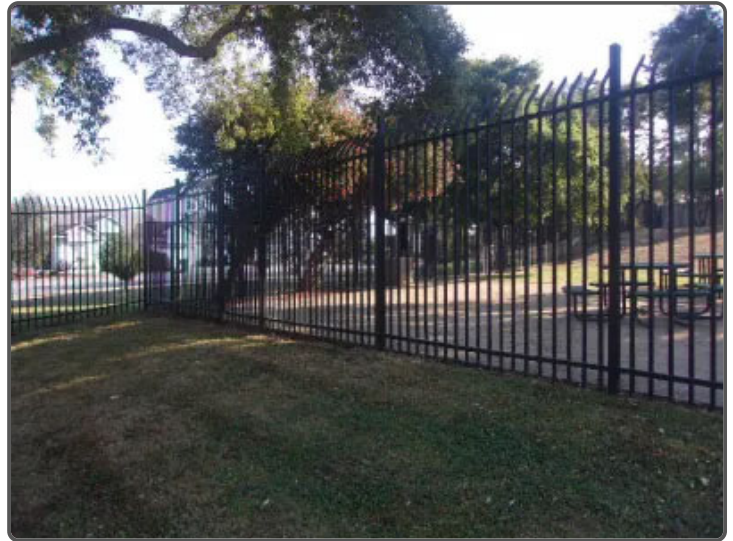
No problems noted or reported at time of site visit. With regular painting and maintenance expect a useful life of approximately 20 to 25 years from this fencing. Remaining life based on current age.

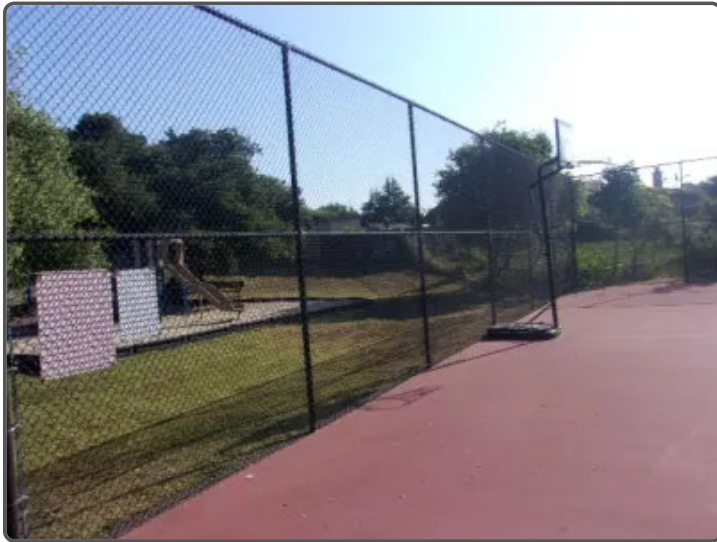
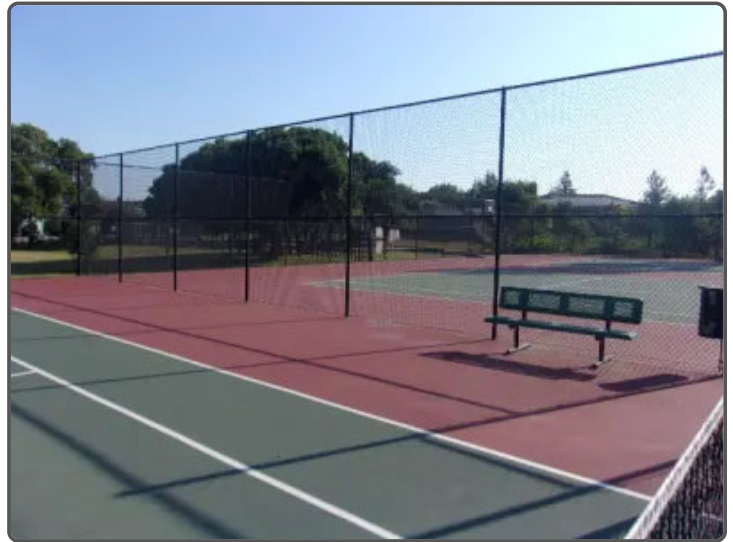
**Comp #** 1003 **Chain Link Fencing - Replace**

No warping or broken links noted at time of site visit. We recommend funding to replace this chain link fencing approximately every 25 to 30 years to maintain appearance and ensure proper function. Remaining life based on current age.

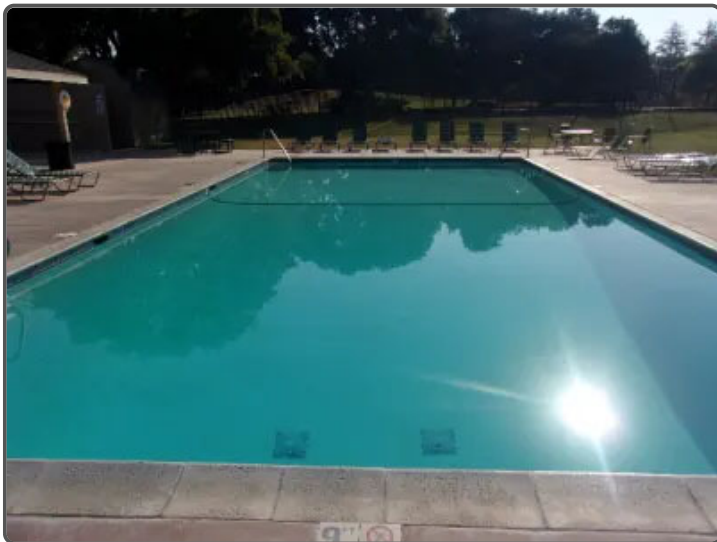
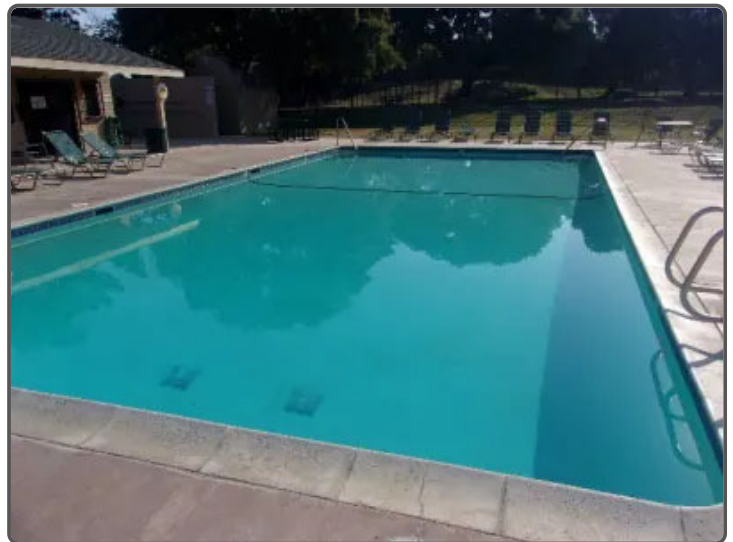
Comp # 1101 Pool - Resurface

No discoloration or surface loss noted at time of site visit. Perform regular, professional maintenance and keep debris from collecting at the bottom to ensure full life from this surface. Remaining life based on current age.

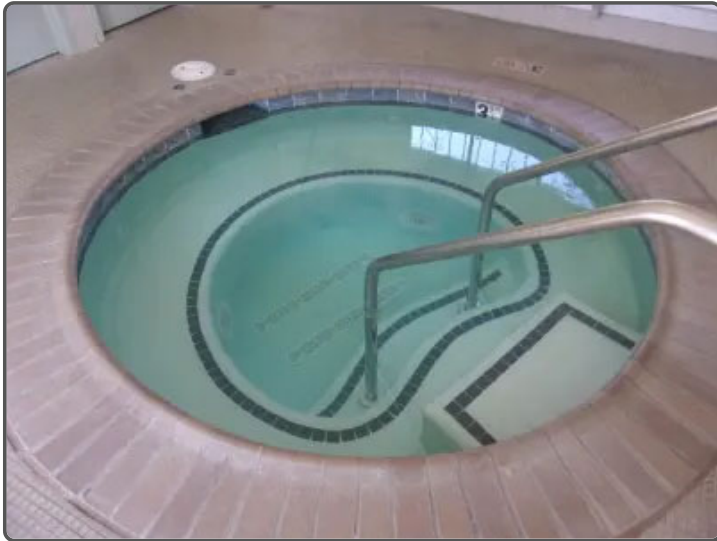
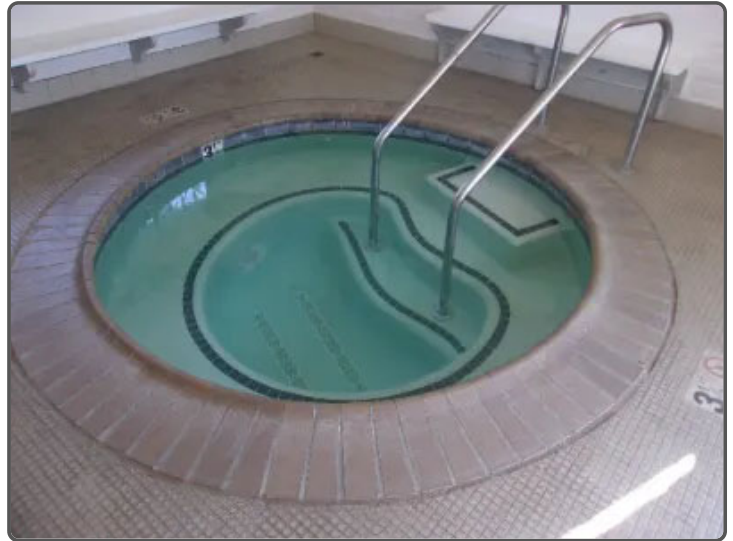
Comp # 1102 Spa - Resurface

No problems noted at time of site visit. Because the entire spa surface experiences traffic wear expect to replaster this spa approximately every 4 to 6 years. Remaining life based on current age.

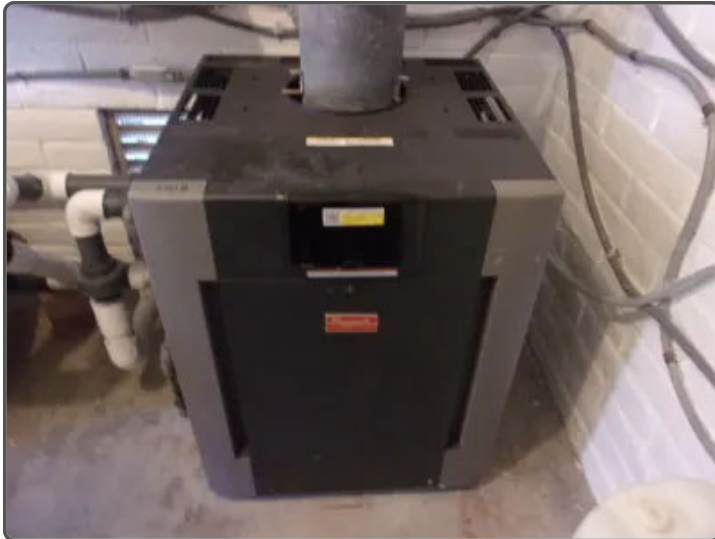
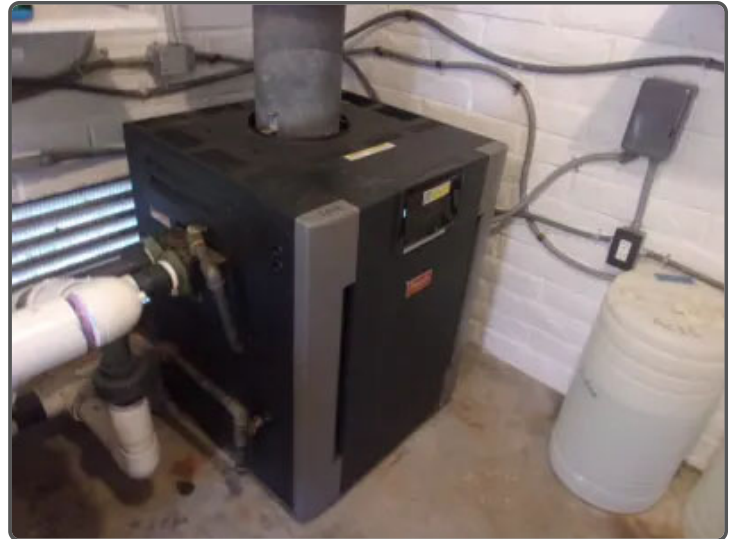
**Comp #** 1104 **Pool Heater - Replace**

No reports of problems at time of site visit. This type of pool heater typically has a useful life of approximately 10 to 12 years. Remaining life based on current age.

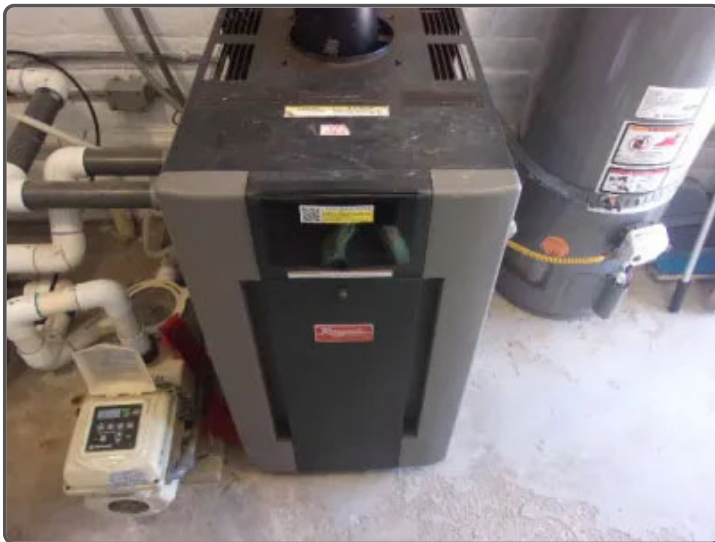
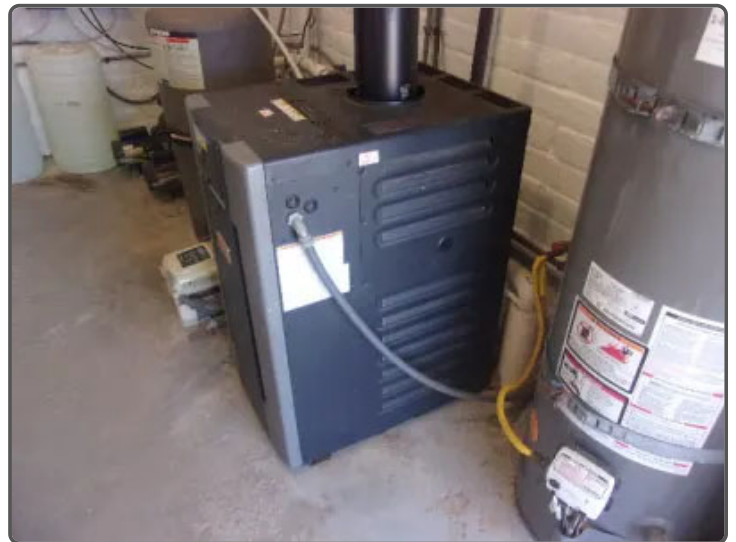
Comp # 1105 Spa Heater - Replace

No reports of problems at time of site visit. Expect a typical useful life of approximately 8 to 10 years from this heater.  
Remaining life based on current age.

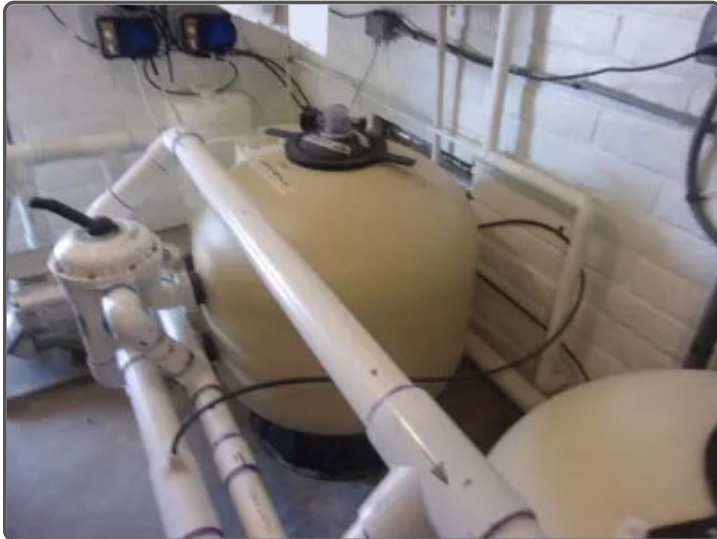
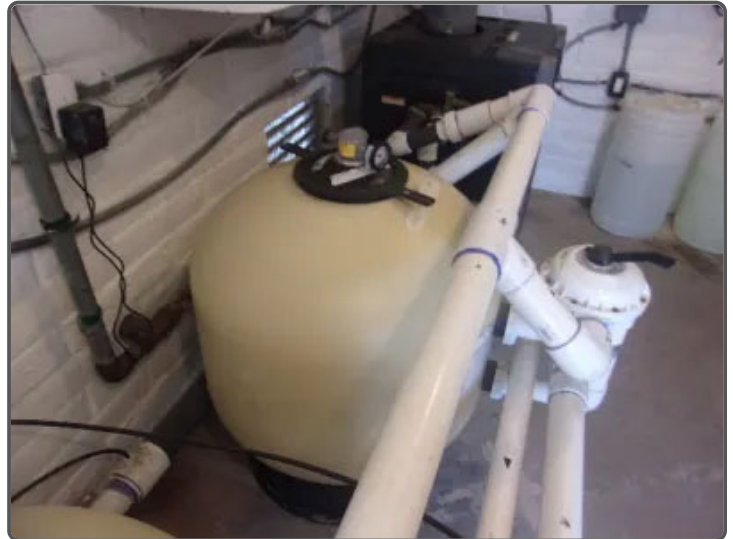
Comp # 1107 Pool Filter - Replace

No problems noted or reported at time of site visit. These type of filters have a life expectancy of approximately 10 to 12 years. Remaining life based on current age.

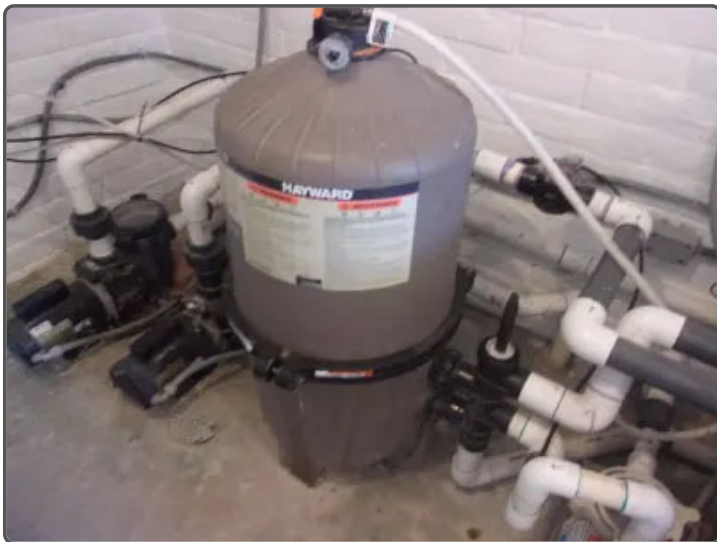
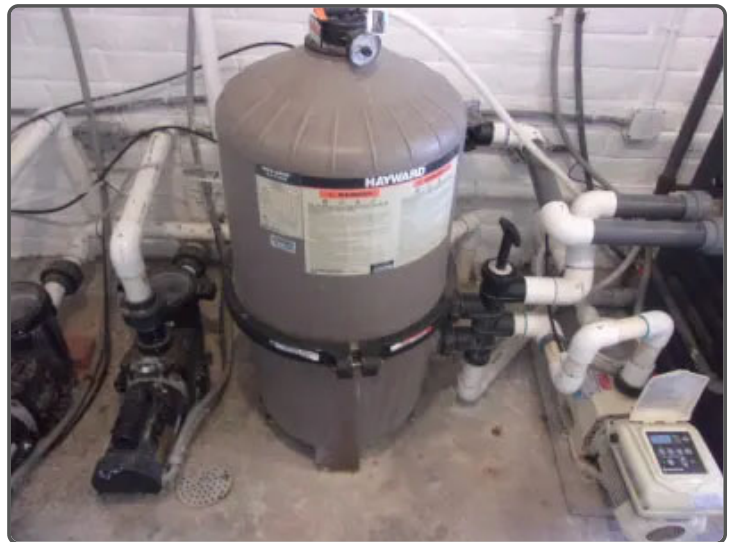
Comp # 1108 Spa Filter - Replace

Spa filter is in working condition. No problems were noted or reported at time of site visit. This type of filter has a life expectancy of approximately 10 to 12 years.

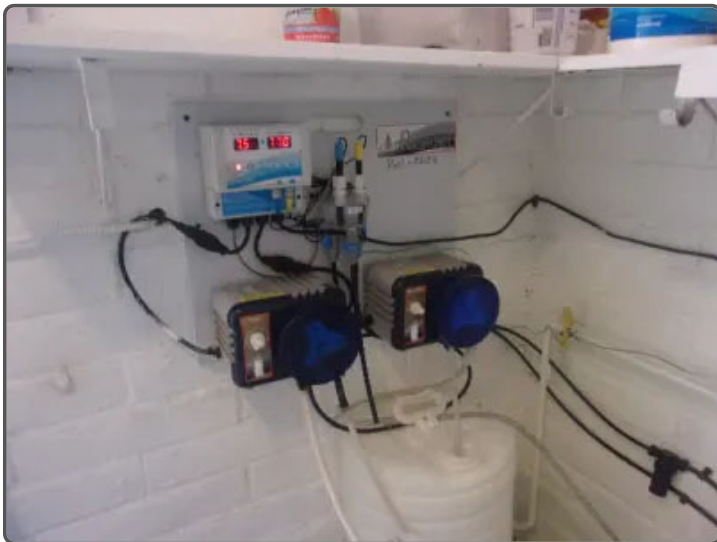
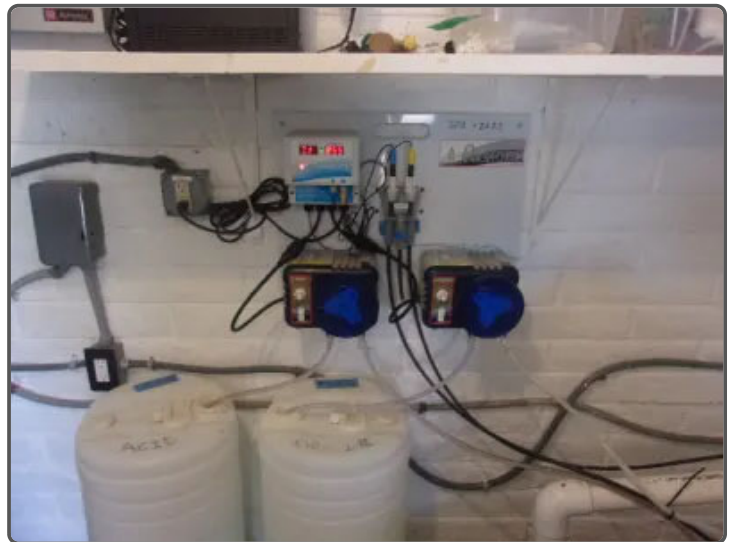
Comp # 1111 Pool/Spa Chlorinators - Replace

No reports of problems at time of site visit. We recommend funding to replace these chlorinators approximately every 8 to 10 years to ensure proper function and to keep up with current technology. Remaining life based on current age.

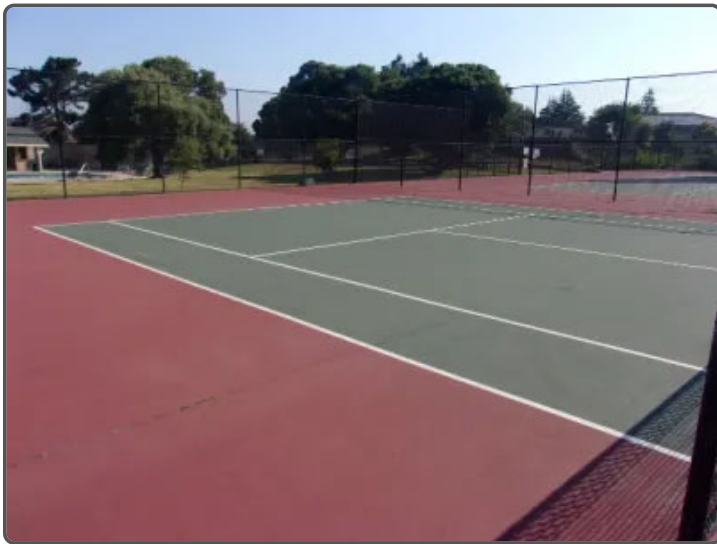
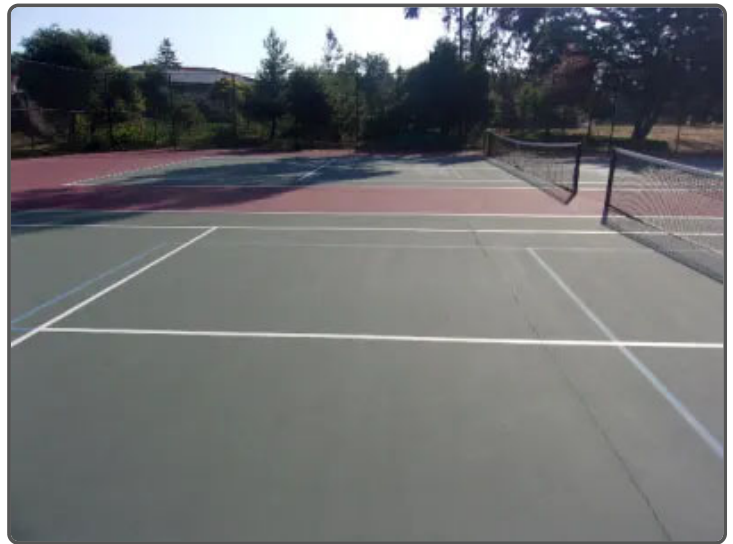
Comp # 1202 Tennis Court - Replace / Rehab.

No problems noted at time of site visit. We recommend funding for a complete replacement of these tennis courts approximately every 30 to 35 years to maintain appearance and ensure proper function. Remaining life based on current age.

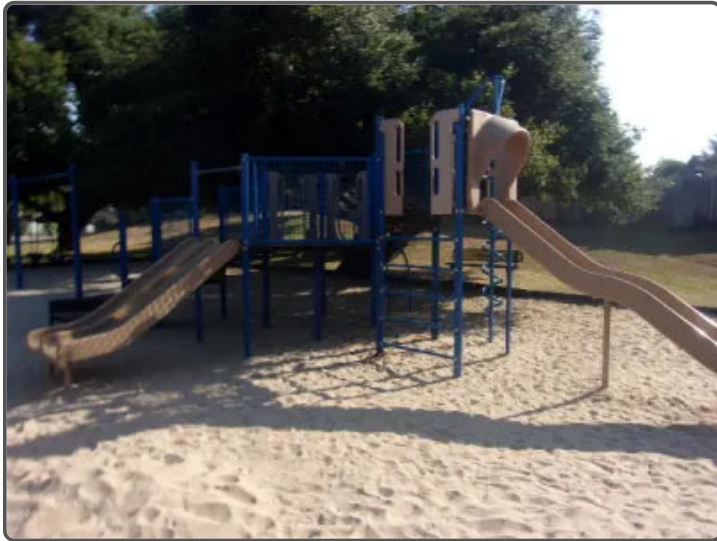
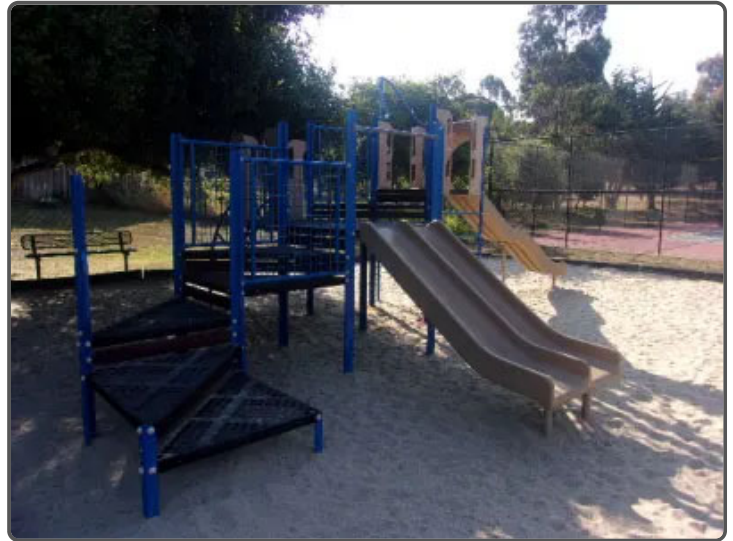
**Comp #** 1301 **Play Structure - Replace**

No significant signs of wear or damage noted at time of site visit. We recommend funding to replace this structure approximately every 18 to 20 years to maintain appearance and keep up with current decorative taste.

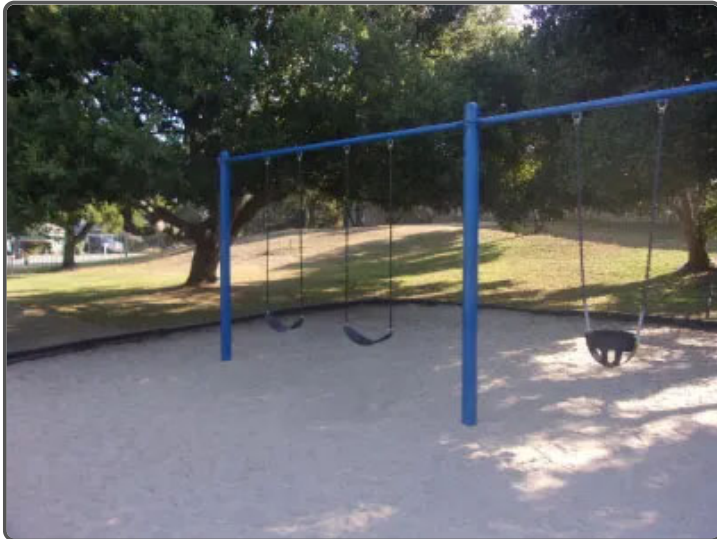
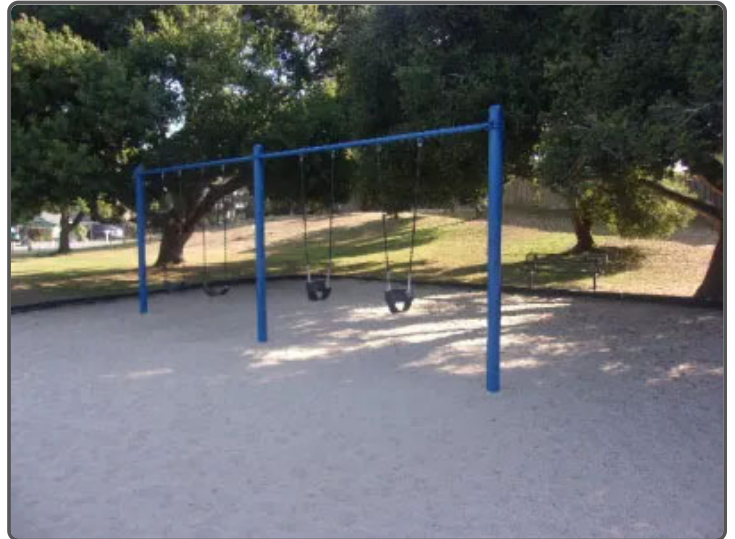
Comp # 1302 Swing Set - Replace

Although this component may reach an extended life, we are funding to replace this swing set approximately every 25 years.

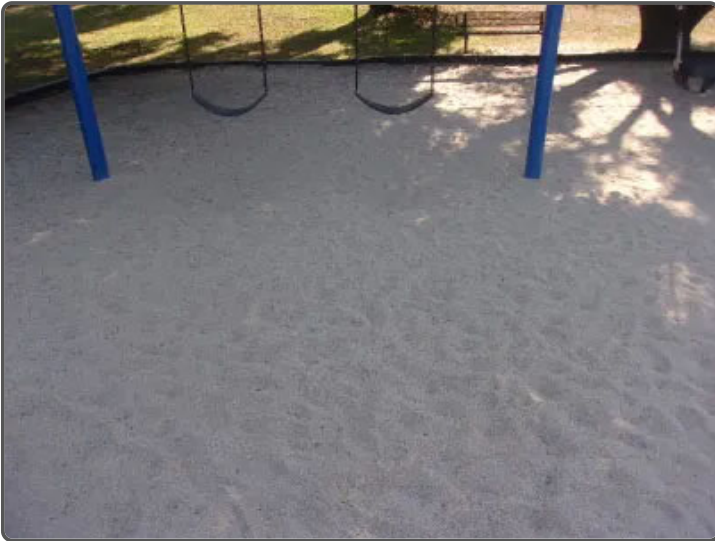
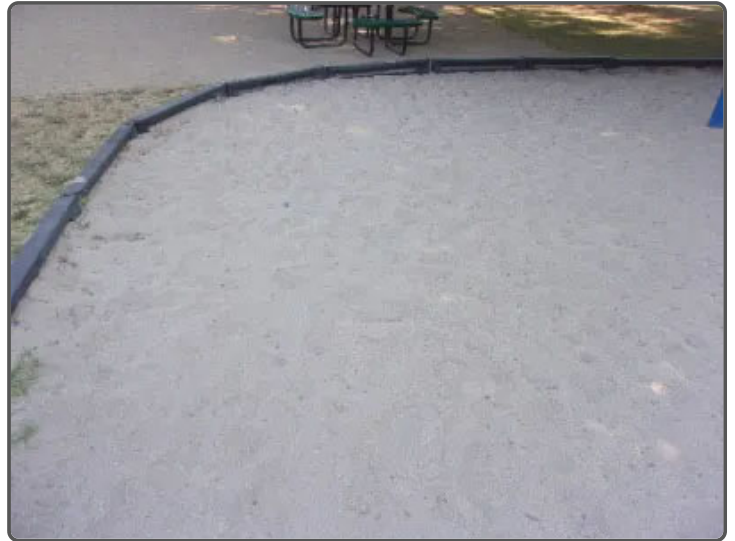
Comp # 1303 Sand Lot - Replenish

No reports of problems at time of site visit. We recommend funding to generally replenish this sand lot area approximately every 2 to 3 years to ensure proper function as a safety feature.

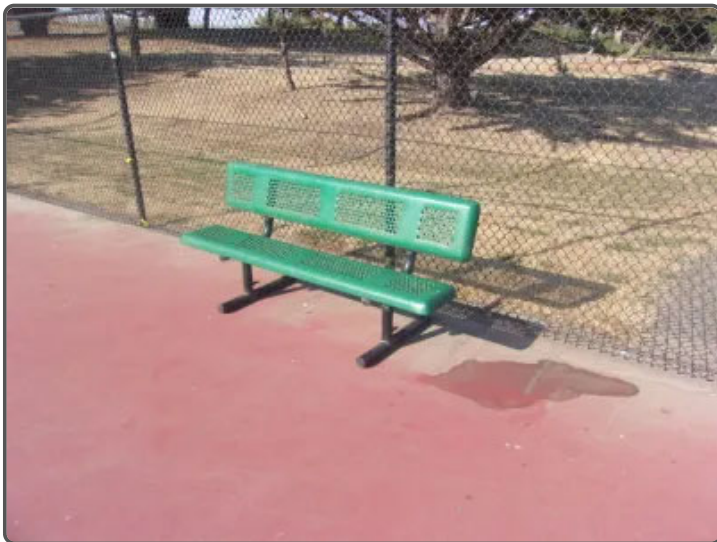
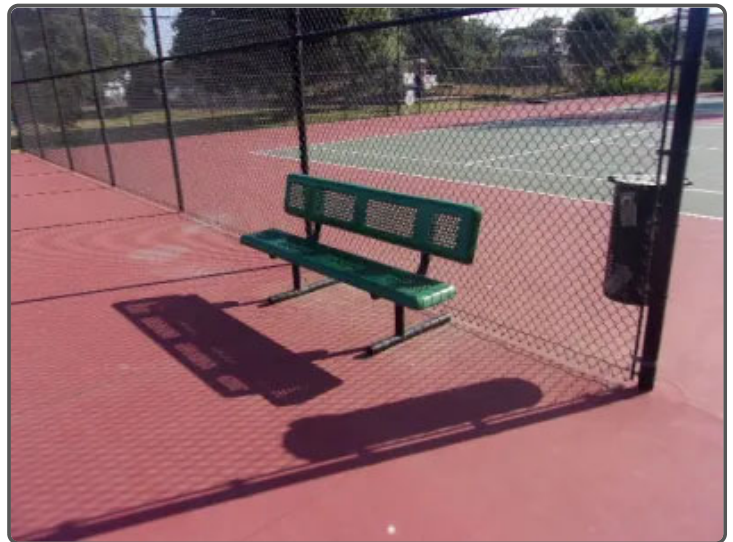
Comp # 1307 Benches - Replace

No problems noted with benches at time of site visit. We recommend funding to replace these benches approximately every 10 to 15 years to maintain appearance. Remaining life based on current age.
