# Shadow Oak

## Level 1 Reserve Study

## Executive Summary - Shadow Oak - ID # 22545

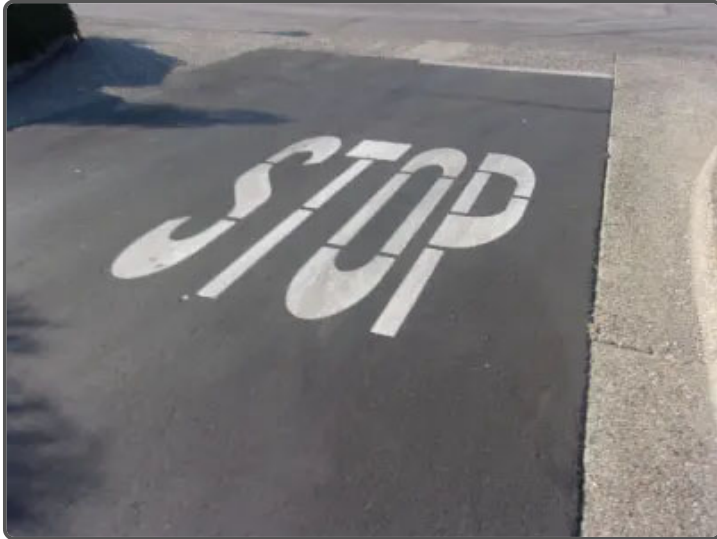
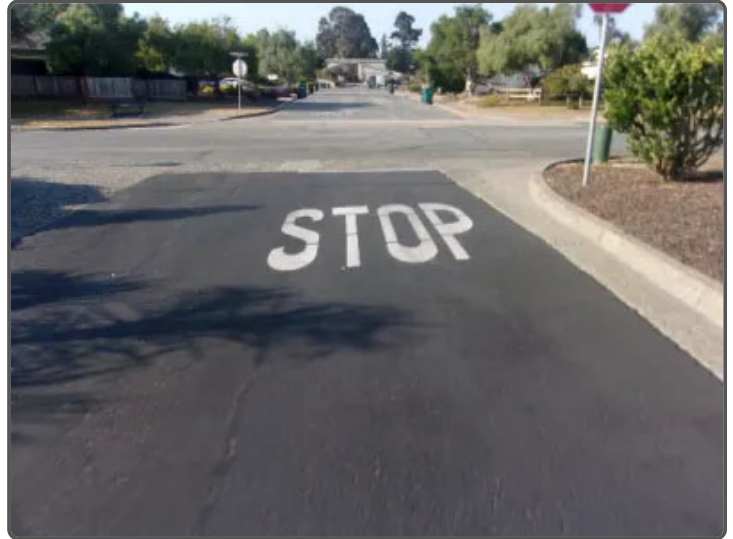
(1) Sign - Madras Pl.

(2) Signs - Total

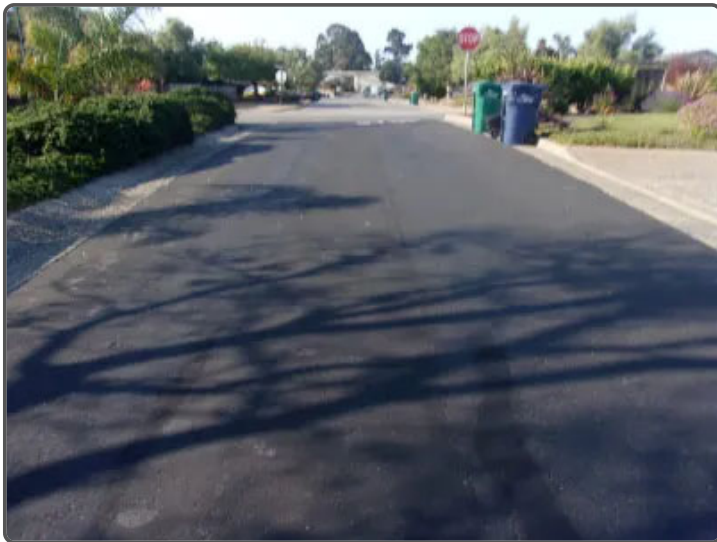
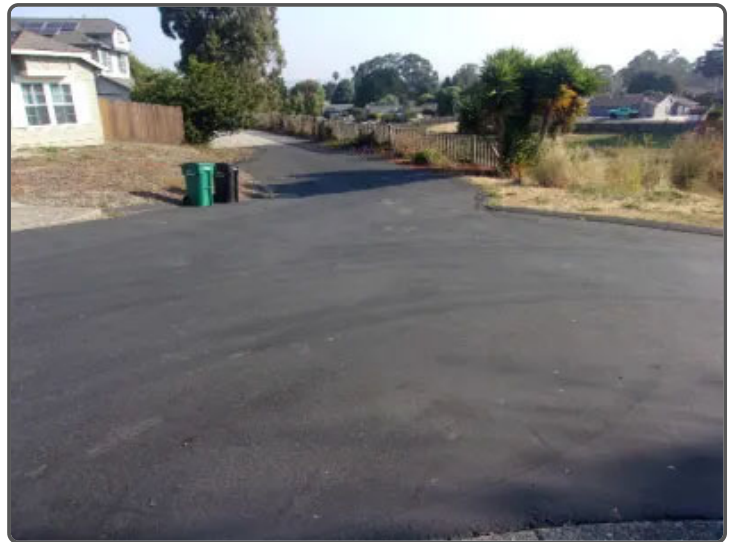
**Comp #**      **401**    **Asphalt - Major Rehab.**

With regular preventative maintenance (see Comp# 402 Asphalt - Preventative Maintenance) asphalt surface should reach a typical useful life of 30 plus years. Once the asphalt has reached the end of its useful life there are two main categories for rehabilitation: overlay and replacement. An overlay typically involves overlaying the existing asphalt with 1.5 - 2" of new asphalt. Replacement typically involves either completely removing and replacing the asphalt or pulverizing the existing surface in place and using it as a base for a new asphalt surface. An overlay will cost significantly less than replacement but may not be possible if the condition of the existing surface is in poor condition and the overlayed surface will only reach a useful life of 10 to 20 years. The complete replacement will provide a new surface and should experience a life of at least 20 years to over 30 based on preventative maintenance. For the purposes of this study we have funded for an overlay.

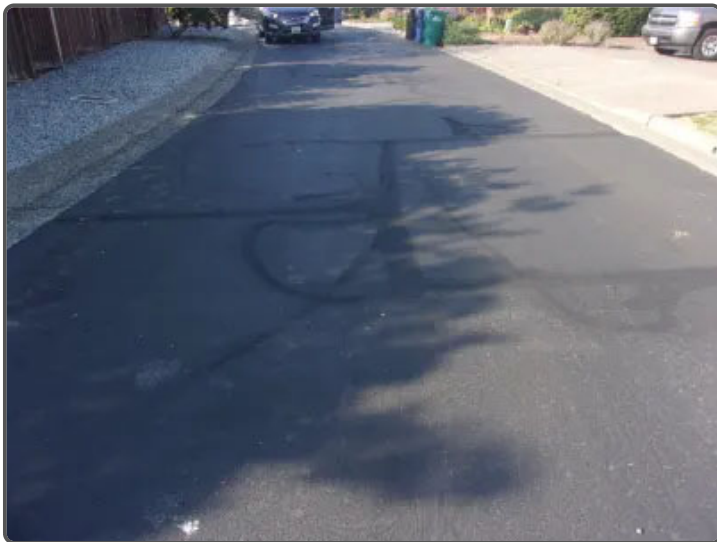
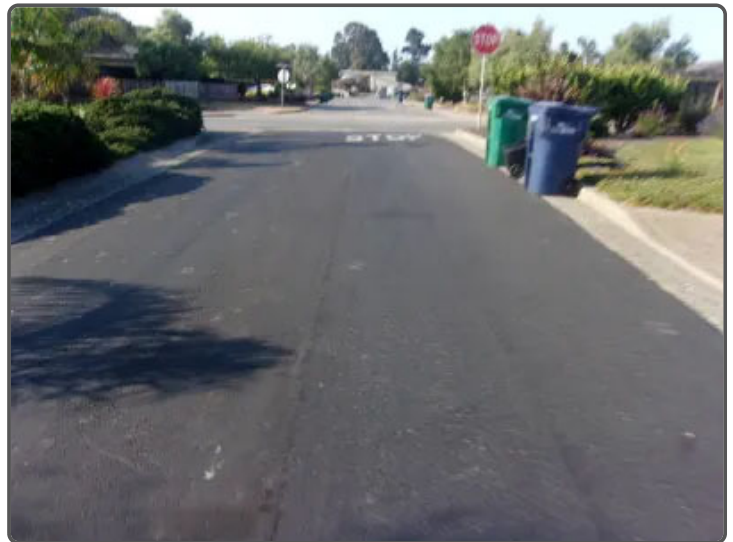
**Comp #**      **402**    **Asphalt - Preventive Maintenance**

There are two main types of asphalt sealing products, those with aggregate (slurry seals) and those without (seal coats). Seal coats provide protection from water intrusion and in general are adequate for newer asphalt surfaces or those surfaces that are in good condition. As a surface ages a more heavy duty slurry seal application may provide better protection as well as some restorative qualities. Slurry seals cost more but last significantly longer than a seal so the increased cost is more or less offset by the lower frequency of required application. We recommend having the asphalt inspected regularly by a licensed engineer or asphalt expert. Ultimately our goal is to provide adequate funding so that the board can choose the best application for their asphalt based on its current condition and recommendations from those experts that have inspected the asphalt. For the purposes of this report we have funded for a seal coat.

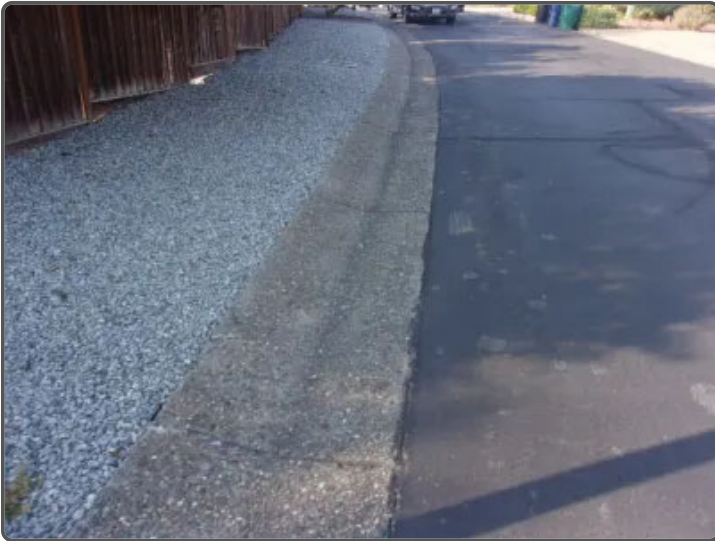
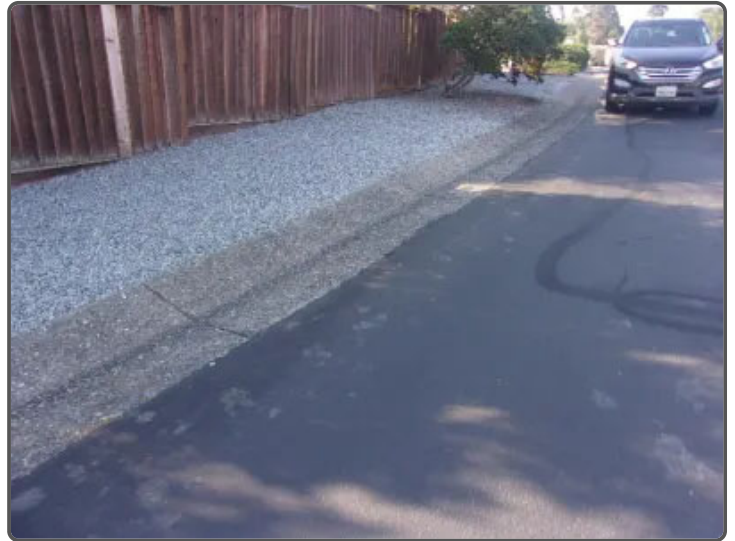
**Comp #**      **403**    **Concrete - Repair/Replace**

We recommend making local repairs as necessary as an operating expense and funding for an allowance to make more significant repairs to these concrete surfaces approximately every 8 to 10 years.
