# Arrowleaf

## Level 1 Reserve Study

**Report Period - 1/1/2025 to 12/31/2025**

Arrowleaf Homeowners Association is a 4-unit community consisting of single family homes, located Salinas, CA. Construction on the common elements was completed in approximately 1997.

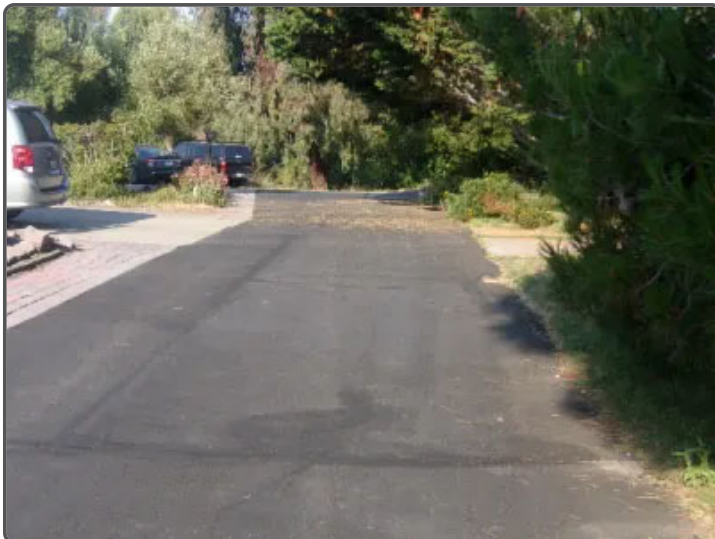
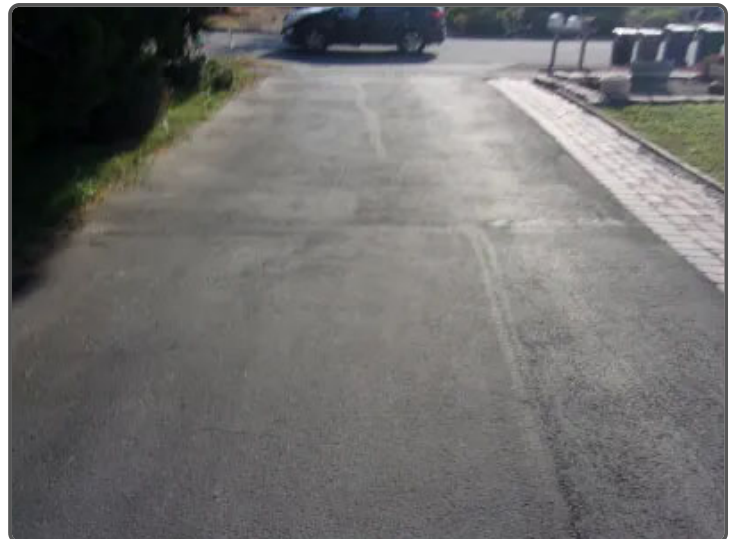
Comp # 401 Asphalt - Major Rehab.

**Life Expectancy:** 30 **Remaining Life:** 24

With regular preventative maintenance (see Comp# 402 Asphalt - Preventative Maintenance) asphalt surface should reach a typical useful life of 30 plus years. Once the asphalt has reached the end of its useful life there are two main categories for rehabilitation: overlay and replacement. An overlay typically involves overlaying the existing asphalt with 1.5 - 2" of new asphalt. Replacement typically involves either completely removing and replacing the asphalt or pulverizing the existing surface in place and using it as a base for a new asphalt surface. An overlay will cost significantly less than replacement but may not be possible if the condition of the existing surface is in poor condition and the overlaid surface will only reach a useful life of 10 to 20 years. The complete replacement will provide a new surface and should experience a life of at least 20 years to over 30 based on preventative maintenance. For the purposes of this study we have funded for an overlay.

**Best Cost:** \$12,900.00

\$6.00/Sq.ft.; Estimate to rehab

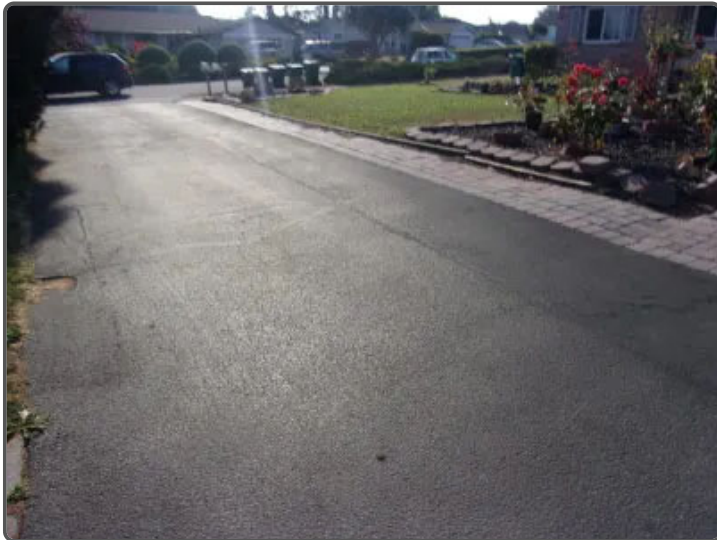
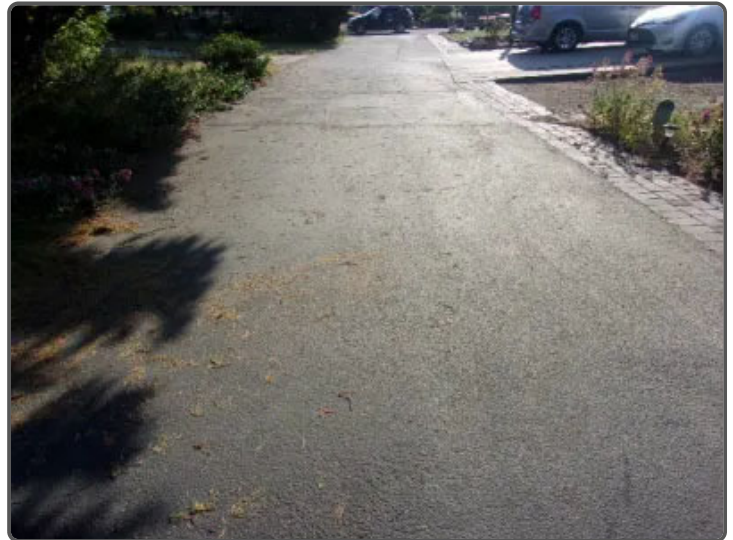
Comp # 402 Asphalt - Preventive Maintenance

**Life Expectancy:** 5 **Remaining Life:** 4

There are two main types of asphalt sealing products, those with aggregate (slurry seals) and those without (seal coats). Seal coats provide protection from water intrusion and in general are adequate for newer asphalt surfaces or those surfaces that are in good condition. As a surface ages a more heavy duty slurry seal application may provide better protection as well as some restorative qualities. Slurry seals cost more but last significantly longer than a seal so the increased cost is more or less offset by the lower frequency of required application. We recommend having the asphalt inspected regularly by a licensed engineer or asphalt expert. Ultimately our goal is to provide adequate funding so that the board can choose the best application for their asphalt based on its current condition and recommendations from those experts that have inspected the asphalt. For the purposes of this report we have funded for a seal coat.

**Best Cost:** \$4,300.00

\$2.00/Sq.ft.; Estimate to seal

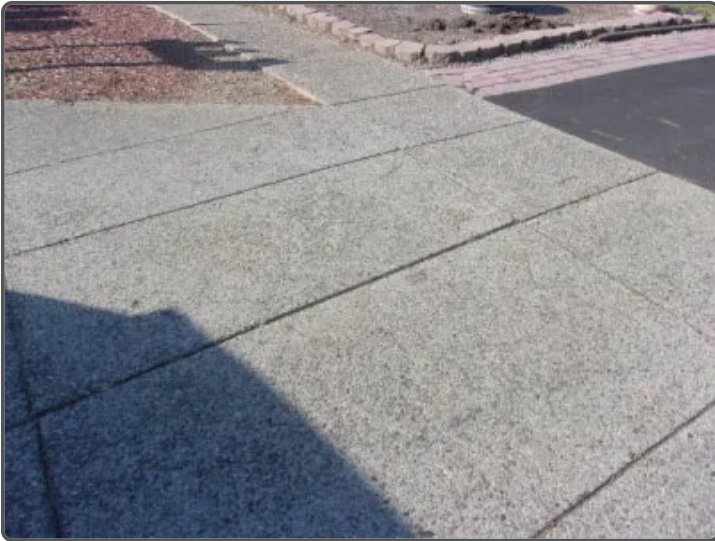
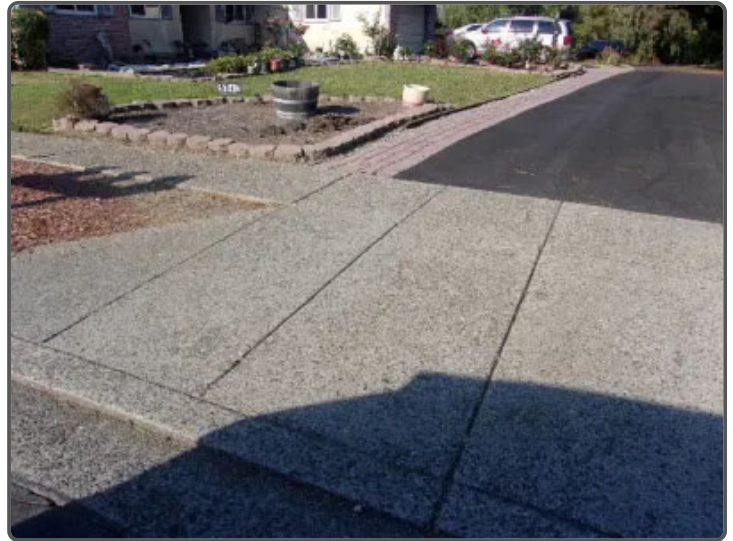
Comp # 403 Concrete - Repair/Replace

**Life Expectancy:** 10 **Remaining Life:** 2

We recommend making local repairs as necessary as an operating expense and funding for an allowance to make more significant repairs to these concrete surfaces approximately every 8 to 10 years.

**Best Cost:** \$2,500.00

Allowance to repair/replace
