# **Clover Trail**

## **Level 1 Reserve Study**

**Report Period - 1/1/2025 to 12/31/2025**

Clover Trail Arrowleaf Homeowners Association is a 3-unit community consisting of single family homes, located Salinas, CA. Construction on the common elements was completed in approximately 1997.

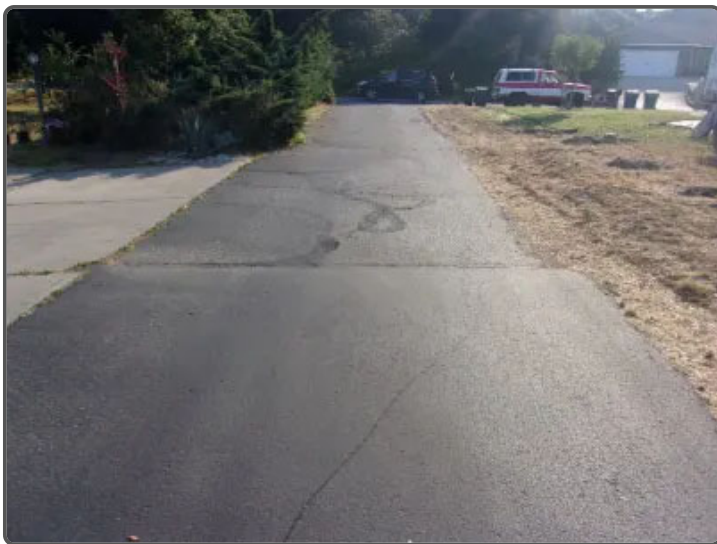
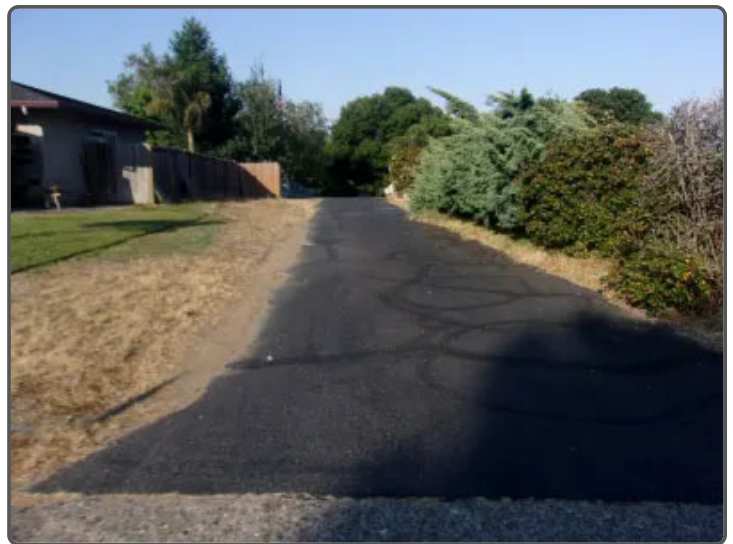
With regular preventative maintenance (see Comp# 402 Asphalt - Preventative Maintenance) asphalt surface should reach a typical useful life of 20 plus years. Once the asphalt has reached the end of its useful life there are two main categories for rehabilitation: overlay and replacement. An overlay typically involves overlaying the existing asphalt with 1.5 - 2" of new asphalt. Replacement typically involves either completely removing and replacing the asphalt or pulverizing the existing surface in place and using it as a base for a new asphalt surface. An overlay will cost significantly less than replacement but may not be possible if the condition of the existing surface is in poor condition and the overlayed surface will only reach a useful life of 10 to 20 years. The complete replacement will provide a new surface and should experience a life of at least 20 years to over 25 based on preventative maintenance. For the purposes of this study we have funded for an overlay.

\$8.00/Sq.ft.; Higher estimate for local repairs

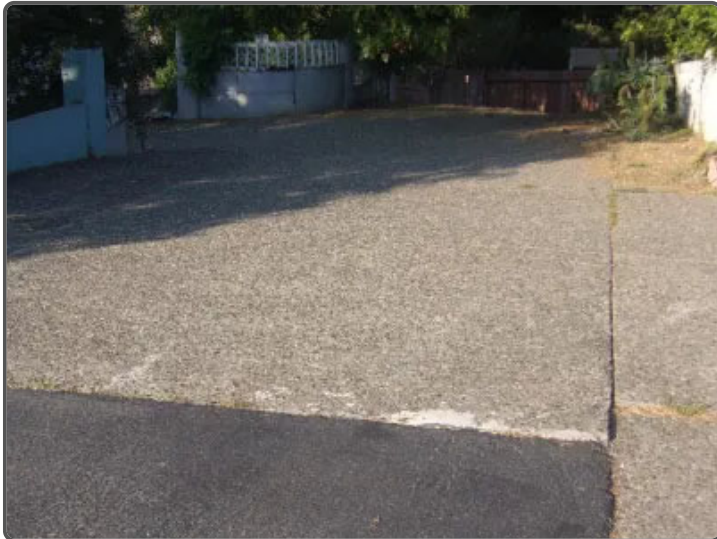
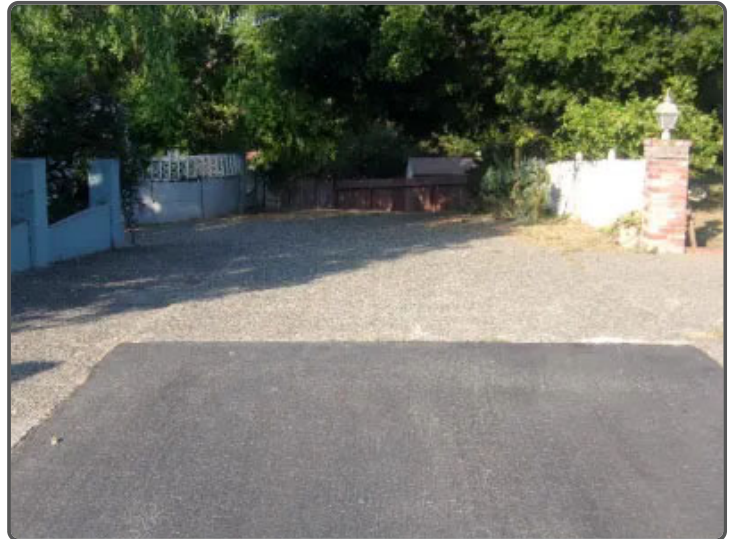
**Comp #**      **403**    **Concrete - Repair/Replace**

We recommend making local repairs as necessary as an operating expense and funding for an allowance to make more significant repairs to these concrete surfaces approximately every 8 to 10 years.

Allowance to repair/replace
