# Sandbur

## Level 1 Reserve Study

**Report Period - 1/1/2025 to 12/31/2025**

## Executive Summary - Sandbur - ID # 22544

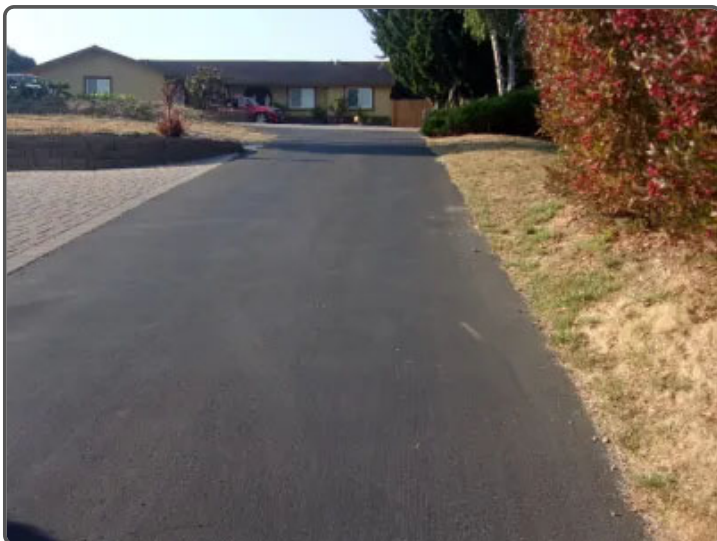
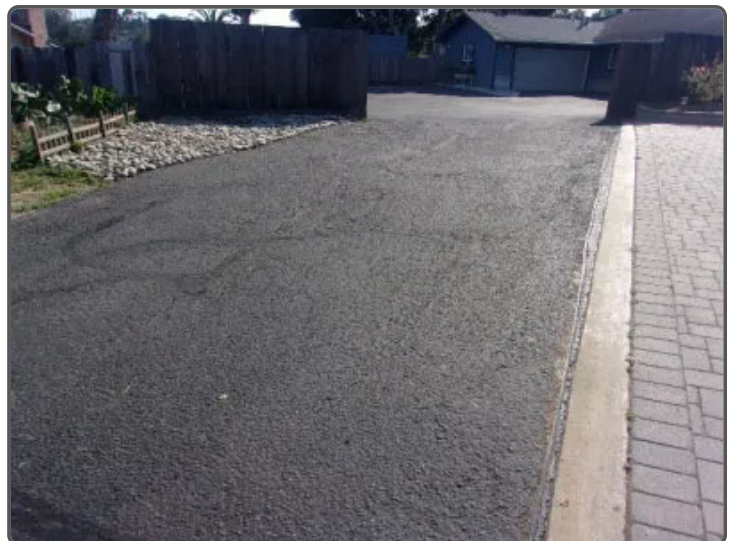
With regular preventative maintenance (see Comp# 402 Asphalt - Preventative Maintenance) asphalt surface should reach a typical useful life of 30 plus years. Once the asphalt has reached the end of its useful life there are two main categories for rehabilitation: overlay and replacement. An overlay typically involves overlaying the existing asphalt with 1.5 - 2" of new asphalt. Replacement typically involves either completely removing and replacing the asphalt or pulverizing the existing surface in place and using it as a base for a new asphalt surface. An overlay will cost significantly less than replacement but may not be possible if the condition of the existing surface is in poor condition and the overlayed surface will only reach a useful life of 10 to 20 years. The complete replacement will provide a new surface and should experience a life of at least 20 years to over 30 based on preventative maintenance. For the purposes of this study we have funded for an overlay.

\$8.00/Sq.ft.; Higher estimate for local repairs

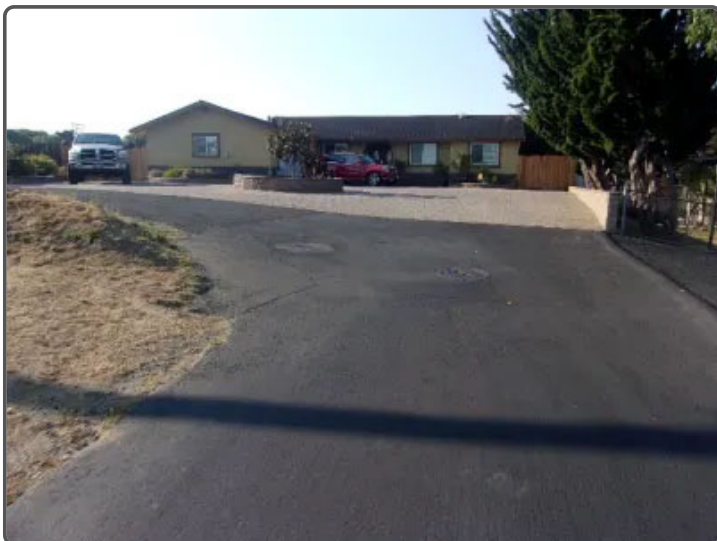
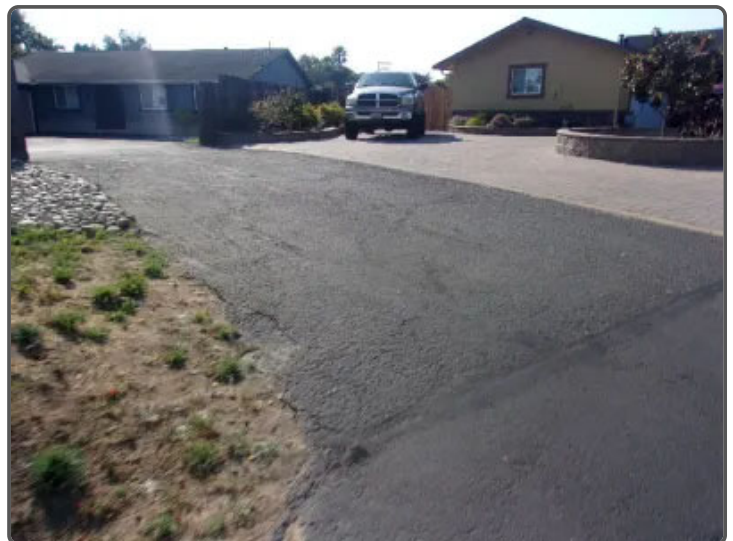
**Comp #**      **401**    **Asphalt - Major Rehab. (Older)**

With regular preventative maintenance (see Comp# 402 Asphalt - Preventative Maintenance) asphalt surface should reach a typical useful life of 30 plus years. Once the asphalt has reached the end of its useful life there are two main categories for rehabilitation: overlay and replacement. An overlay typically involves overlaying the existing asphalt with 1.5 - 2" of new asphalt. Replacement typically involves either completely removing and replacing the asphalt or pulverizing the existing surface in place and using it as a base for a new asphalt surface. An overlay will cost significantly less than replacement but may not be possible if the condition of the existing surface is in poor condition and the overlayed surface will only reach a useful life of 10 to 20 years. The complete replacement will provide a new surface and should experience a life of at least 20 years to over 30 based on preventative maintenance. For the purposes of this study we have funded for an overlay.

\$8.00/Sq.ft.; Higher estimate for local repairs

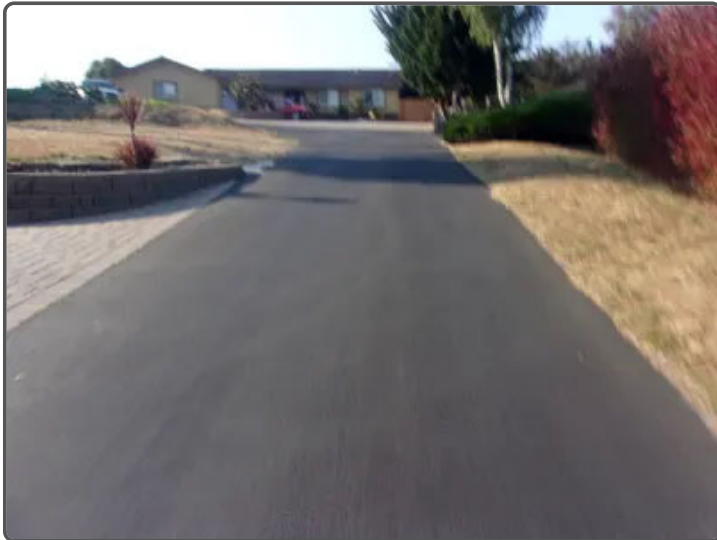
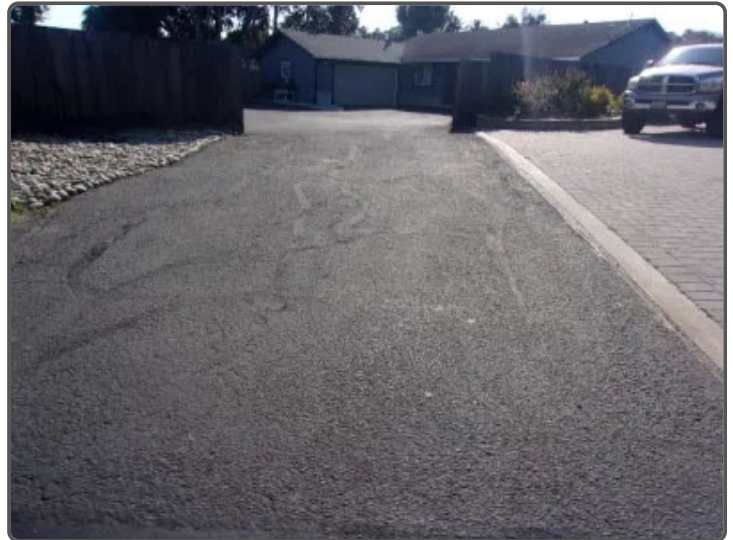
**Comp #**      **402**    **Asphalt - Preventive Maintenance**

There are two main types of asphalt sealing products, those with aggregate (slurry seals) and those without (seal coats). Seal coats provide protection from water intrusion and in general are adequate for newer asphalt surfaces or those surfaces that are in good condition. As a surface ages a more heavy duty slurry seal application may provide better protection as well as some restorative qualities. Slurry seals cost more but last significantly longer than a seal so the increased cost is more or less offset by the lower frequency of required application. We recommend having the asphalt inspected regularly by a licensed engineer or asphalt expert. Ultimately our goal is to provide adequate funding so that the board can choose the best application for their asphalt based on its current condition and recommendations from those experts that have inspected the asphalt. For the purposes of this report we have funded for a seal coat.

\$0.80/Sq.ft.; Higher estimate for local repairs
